Title: Relocation of Receiver Air-con exhaust fans

16 Production Receivers at the MRO

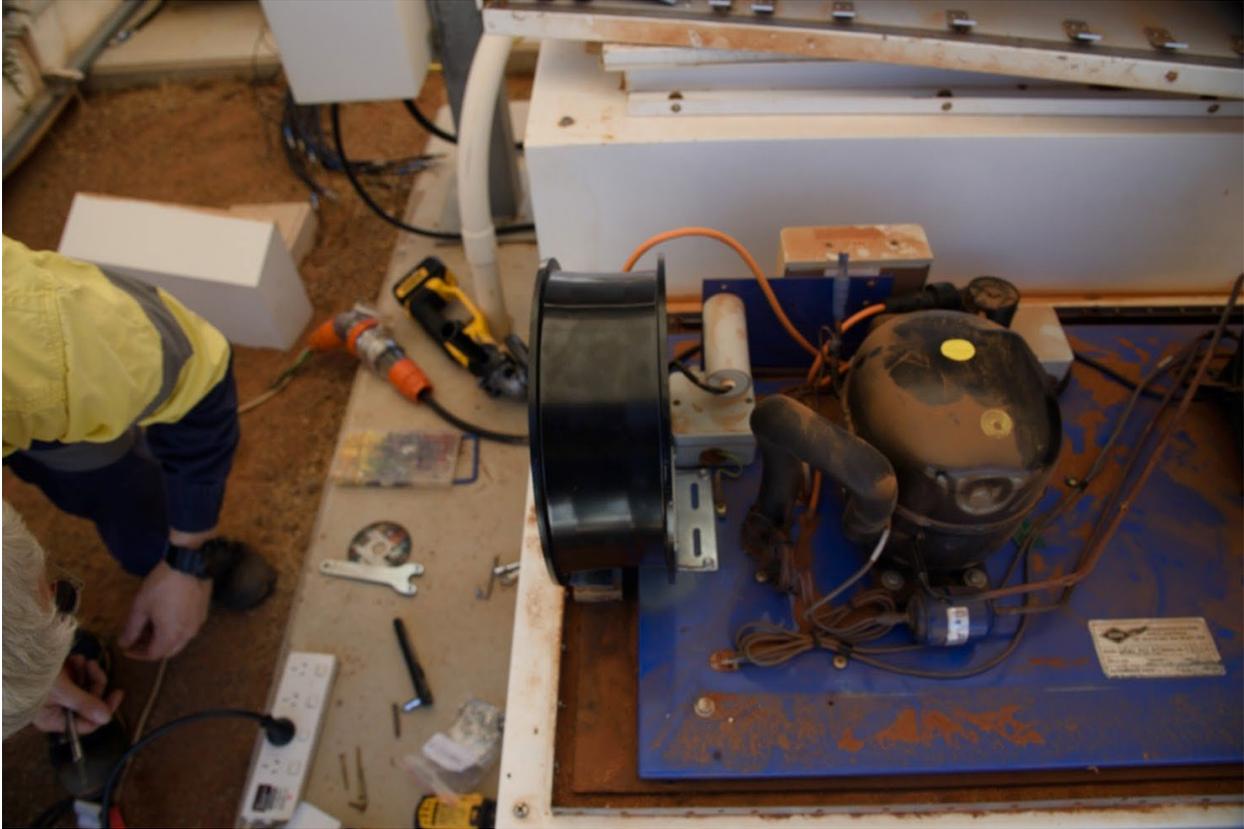
FIGURE 1: EXHAUST FAN MOUNTED TO AIR-CON SKID VIA NEW BRACKETS.

In order to improve air-conditioner serviceability, in particular for periodic fan replacements to pre-empt motor failures, we had the GCo crew re-locate the air-con exhaust fans from the covers, to the main air-con "skid", during the first run of pre-emptive fan motor replacements conducted during the Feb site trip. We also fitted crimp terminals on the power cables instead of the previous soldered connections.

Relocating the exhaust fan onto the air-con skid meant that the power cable could be permanently routed to avoid fouling the cover or other air-conditioner components. Furthermore, due to changing from soldered to crimp terminal connections, the fans can be replaced in the future without the need to solder in the field.

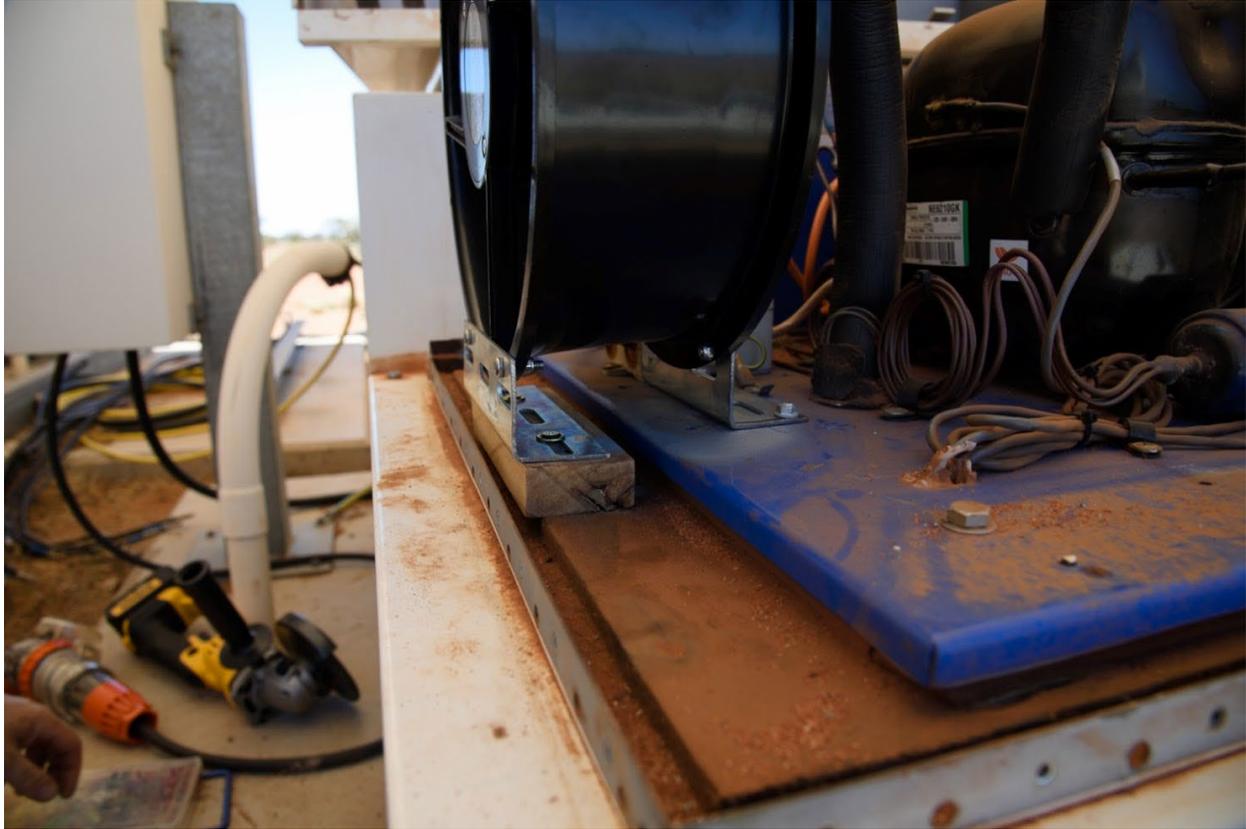
FIGURE 2: CLOSE UP OF MOUNTING BRACKETS AND TIMBER PACKER
