SEPTEMBER 23, 2019

Curtin University

This document provides a brief report outlining the results of visual inspection and first-line testing of the first two modified beam-former boards received from Brett Douglas of Convergence Engineering.

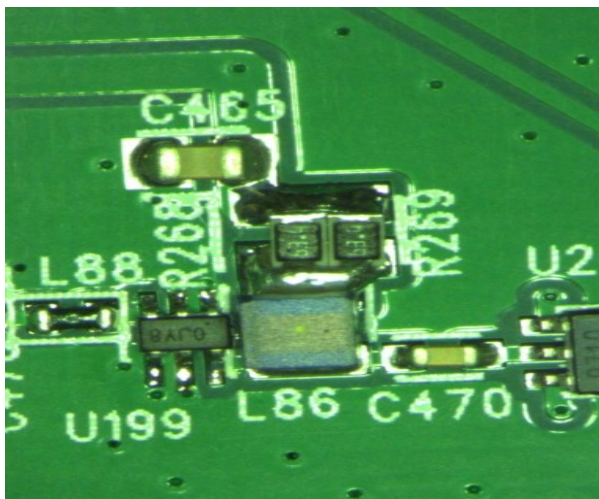
In general there appeared to be somewhat too much solder surrounding the two 63.4 ohm larger resistors and associated bias inductor that drive the input amplifiers in all 16 channels. This can be seen in the first photo shown overleaf, where the designators are R268, R269 and L86 respectively.

FIGURE 1: GENERALLY OK

While this excess solder does not have any immediate effect, it could leave a frozen-in strain which might manifest as a broken joint after time in service particularly due to thermal cycling on site. CIRA would prefer if some means could be found to reduce the amount of solder used on these resistors.

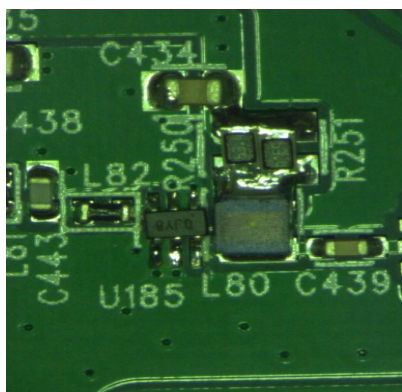
There were some cases where the resistors were partly offset with respect to each other and the underlying copper pads, and in one case (shown below right), the offset was far enough that the resistor was not properly connected. An example of an acceptable offset, and one where the offset was too far, are shown over the page.

FIGURE 2: RESISTORS OFFSET, STILL OK

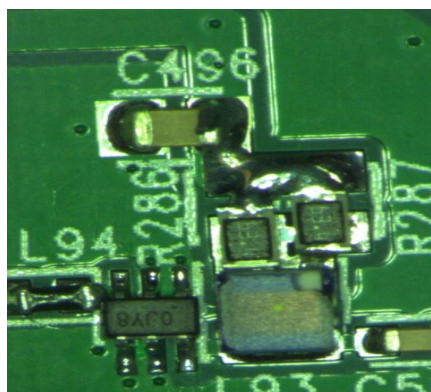
FIGURE 3: RESISTORS OFFSET, R286 TOO CLOSE TO L93

As can be seen in Figure 3 R286 has moved to be too close to the inductor, and the upper end does not make contact with the desired pad. In fact before this fault was rectified only R287 was

connected in circuit. We used a pair of Weller soldering tweezers to re-melt the solder and move R286 back into proper position, after which it made proper contact.

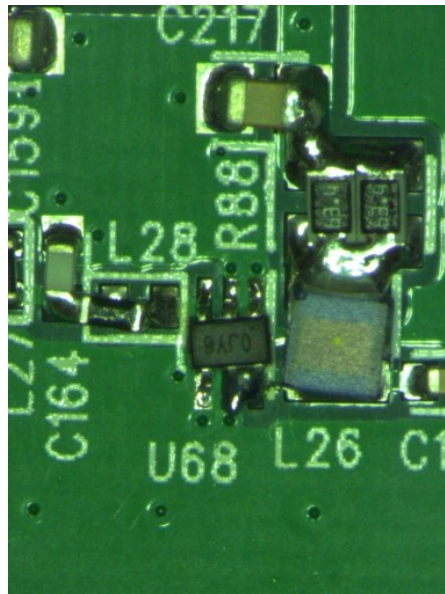
On several channels the input inductor has moved slightly from its original position (see L82 in Figure 2 on the previous page for an example of an inductor that has NOT moved). In the case shown below, the inductor had moved so far that it was no longer making proper contact, see L28 in Figure 4.

FIGURE 4: L28 MISALIGNED

A short circuit between the output pin (pin 6) and ground (pin 5) on the lower side of U68 is also visible in Figure 4 above. This fault would also have been detectable using the multimeter test. Therefore, while unlikely, had the fault remained into power-up testing it would have prevented one of the 5V rails from powering up, potentially damaging the supply.

Again, we used Weller soldering tweezers to correct this fault in a matter of seconds.

Similar to the other issues, this fault was quickly rectified using a regular pencil soldering iron and solder-wick braid.

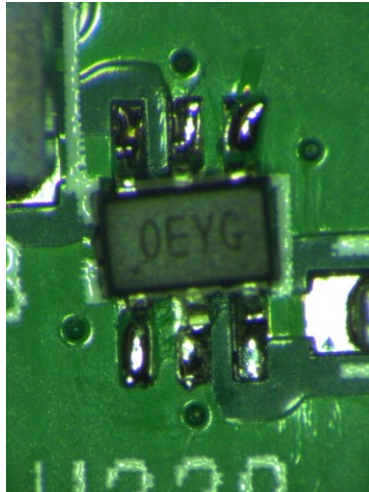
As can be seen over the page in Figure 5 overleaf, the solder has failed to ‘wet’ the lower central ground pin of U229 (pin 2) and while it is in physical contact with the pad, it may not perform correctly at RF frequencies and could become isolated at a later time due to corrosion/oxidation of the contact surfaces.

FIGURE 5: 'DRY' SOLDER JOINT ON PIN 2

This took a little more effort to correct due to the massive copper ground plane rapidly conducting away soldering heat. However re-work flux and a freshly cleaned pencil tip soldering iron were able to re-flow the solder to make a proper contact.

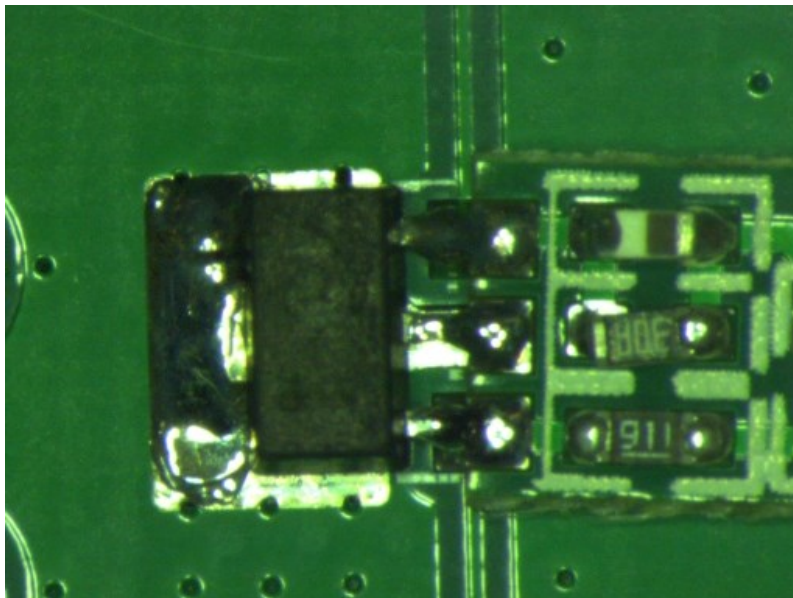
On both beam-former boards, it was observed that while the stabilisation daughterboard was well soldered onto the three device pins, the middle or ground pin of the device was not soldered to the pad on the main board. See below.

FIGURE 6: 'FLOATING' PIN 2

It is uncertain if this could have any RF performance issues particularly at higher frequencies and for long-duration observations where even the tiniest amount of systematic or internal noise can be integrated up to a point where it dwarfs the desired signal.

Therefore we would prefer if the centre pin was also soldered to the main board before the daughterboard was attached.

Addressing this issue took approximately five minutes per board, since we had to use an under-board hot-air source to bring the general board area close to soldering temperatures, and a hot-air pencil from the top to actually melt the solder. We then removed the daughterboard temporarily and used a pencil iron and re-work flux to 'wet' the remaining solder from pin 2 onto the pad on the main board. We then used solder-wick braid to remove excess solder from the ends of the other two pins of the QPB device, and from the castellated vias on the daughterboard. Finally we soldered the daughterboard back into place using a pencil iron and wire solder.
