# CIRA Engineering Technical Memo

## Receiver Temperature Sensor Repair and Failure

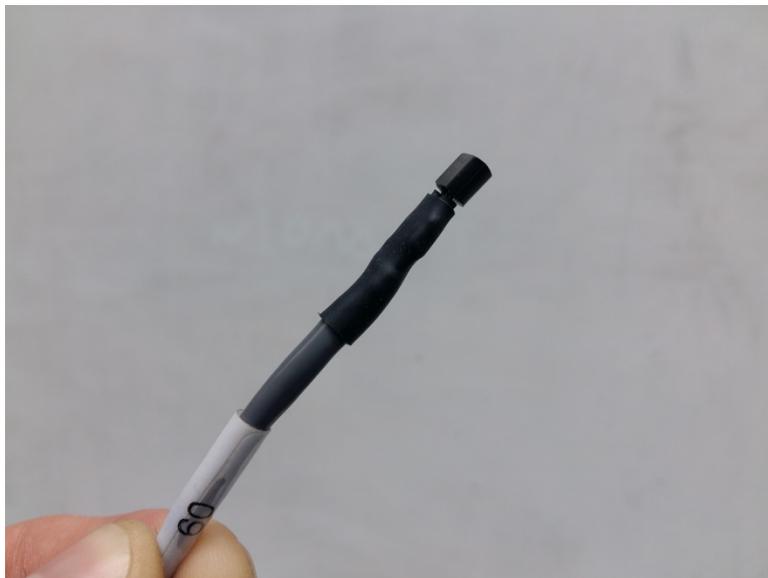
Suspecting the TO92 sensor itself was faulty, we stripped the heat shrink insulation from the sensor in order to measure the sensor output with a multimeter. Before we took a reading we observed evidence of water condensation in and around the leads, suspecting this could have caused leakage currents to flow into the sensor leads.

It is not immediately clear how this would cause other sensors in the same harness to subsequently record higher than the actual temperature. All the temperature sensors share common power supply and ground connections, and we suspect that moisture leaking into these connections could cause all temperature sensors to give faulty readings.

We were uncertain as to the exact source of the moisture; we suspect that moisture had condensed on the inside of the receiver shelter canvas due to high humidity and low overnight temperatures. Early morning winds could then dislodge this moisture to be drawn into the air conditioner enclosure by the cooling fan. It would also be possible for very high winds to blow rain directly into the inlet airflow of the air conditioner system. This would not materially affect the air conditioner plant, as with the exception of the temperature sensors, it is fully sealed.

Figure 1: Temperature sensor before modifications

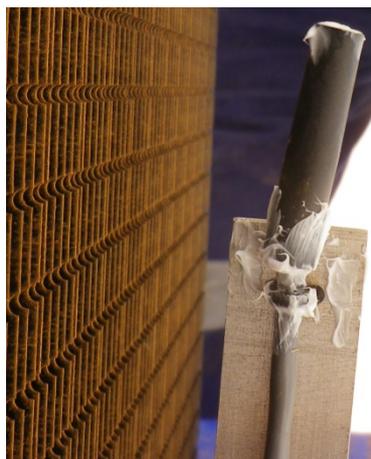
Figure 2: Temperature sensor with heat shrink and silicone fill

It was evident that the original heat-shrink tubing was insufficient to exclude moisture from the temperature sensor mounted between the condenser coil and the main air conditioner cover. Therefore we chose a small length of tubing, loaded it with silicone rubber and used that to enclose the temp sensor. Once the silicone rubber had fully cured, it became completely impervious to moisture, without materially affecting the thermal properties of the sensor. The only possible effect would be to slightly delay the sensor response after the actual outside temperature sensor changed.
