CIRA Engineering Technical Memo

Receiver Earthing Modifications

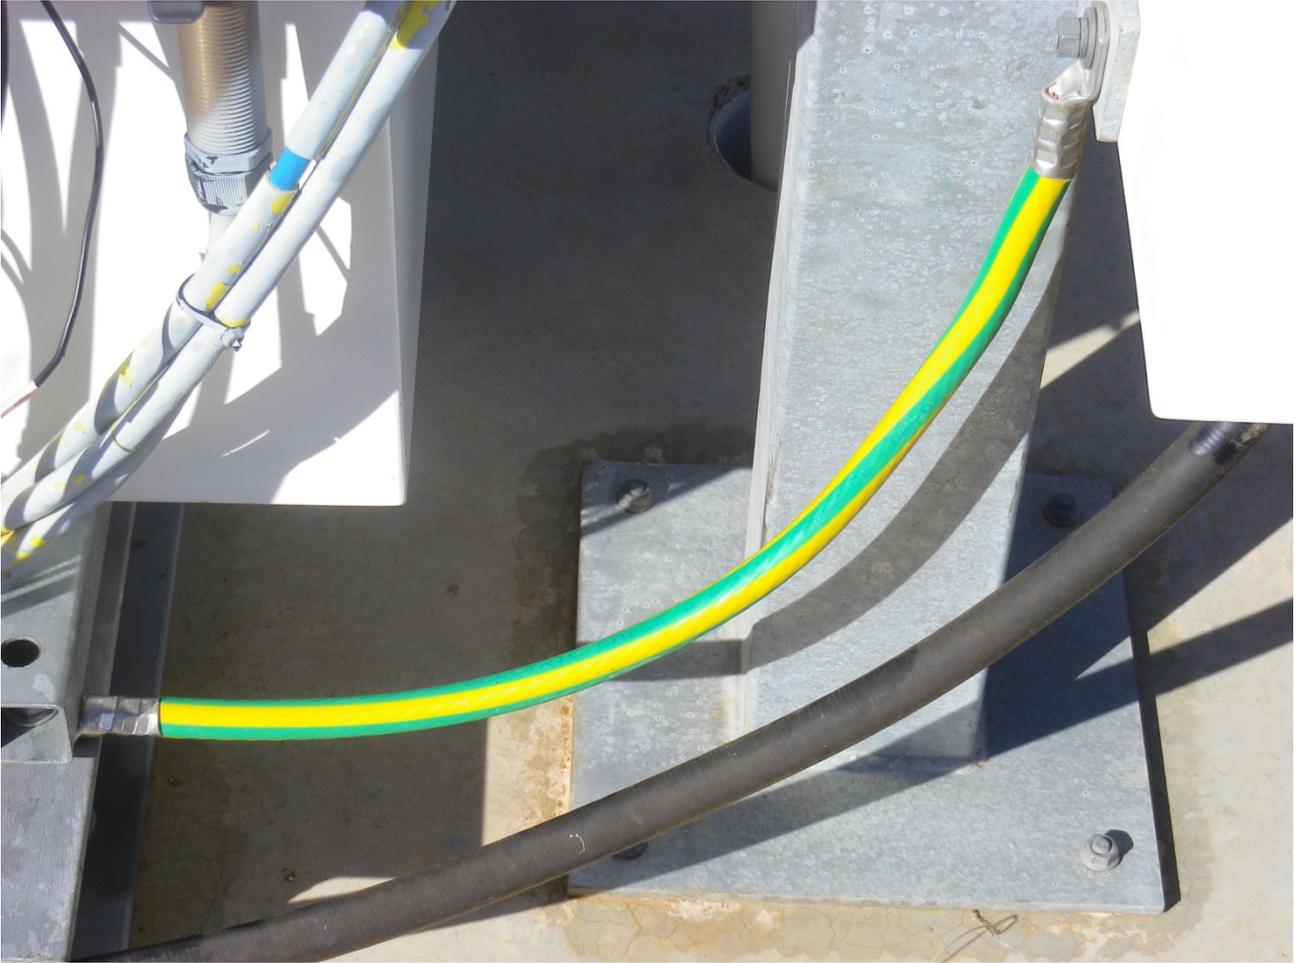
The new setup involved installation of thick (90mm^2) solid copper earth wire directly from the receiver foot, to the earth of the caravan post, effectively wired in parallel with the thin power cable. This provided a much heavier surge path directly to ground instead of through the internal components of a receiver.

Figure 1: New and improved thick copper earth wire
